CONTRACTOR REPORT ARLCD-CR-83049

HIGH FRAGMENTATION STEEL PRODUCTION PROCESS

Chamberlain Manufacturing Corporation
Scranton Army Ammunition Plant
Scranton, PA 18505

January 1984 (pub. date)

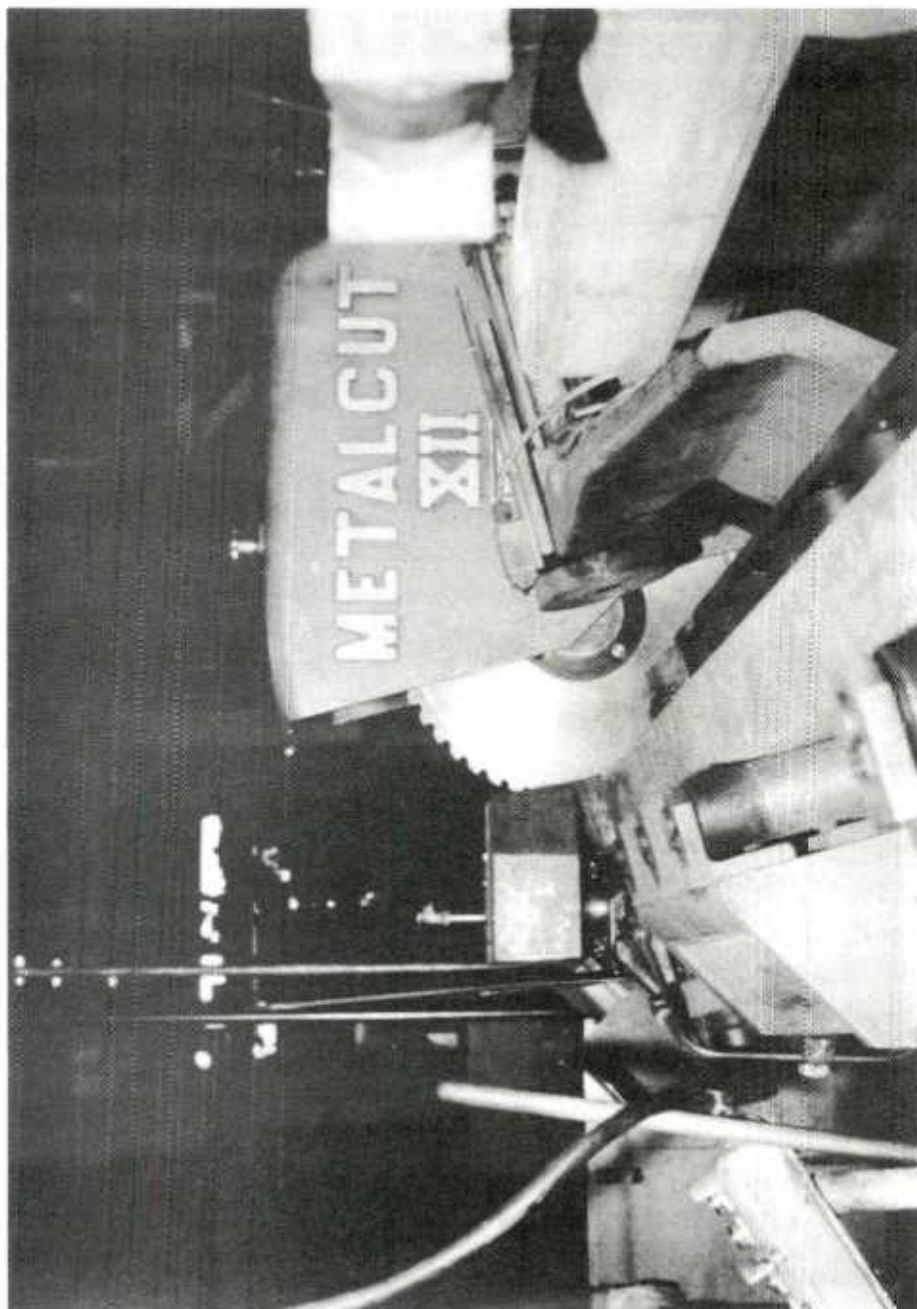
Figure 13. Photo depicting the Metalcut XII saw utilized for sawing the M-549 billets (HF-1 steel).

Due to the difference in the cross-sections and the conditioning of the steel as received from the two (2) steel vendors, a representative billet from each vendor was sawed, measured for length and weighed for a preliminary assessment of consistency. The billet supplied by Republic Steel Co. yielded mulds that averaged 231.77 mm (9-1/8") in length and 32.88 kg. (71.4 lbs.) in weight. The Bethlehem Steel Co. billet yielded mulds that also averaged 231.77 mm (9-1/8") in length but 31.52 kg. (69.5 lbs.) in weight. The weight values are both within standard steel mill tolerances, but a weight tolerance on the plus side is preferable.

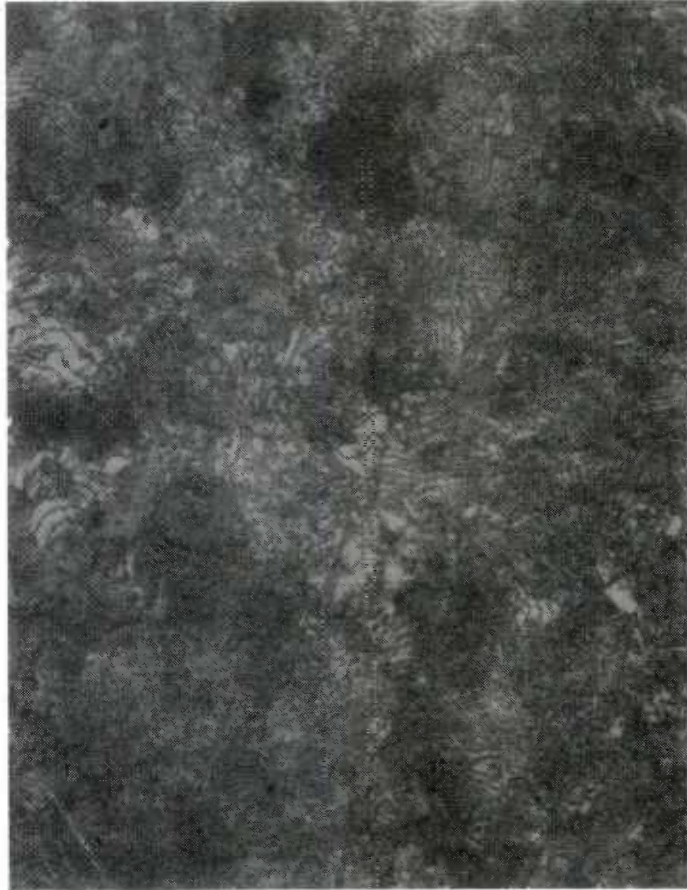
M-549
Nosing

Figure 33. Photomicrograph of structure on base side of heat transition zone. 1000x Nital.

Figure 33 is a photomicrograph illustrating the structure at the base end of the heat transition zone of the nosed piece while figure 34 is a photomicrograph of the structure located at the nosed end of the heat transition zone

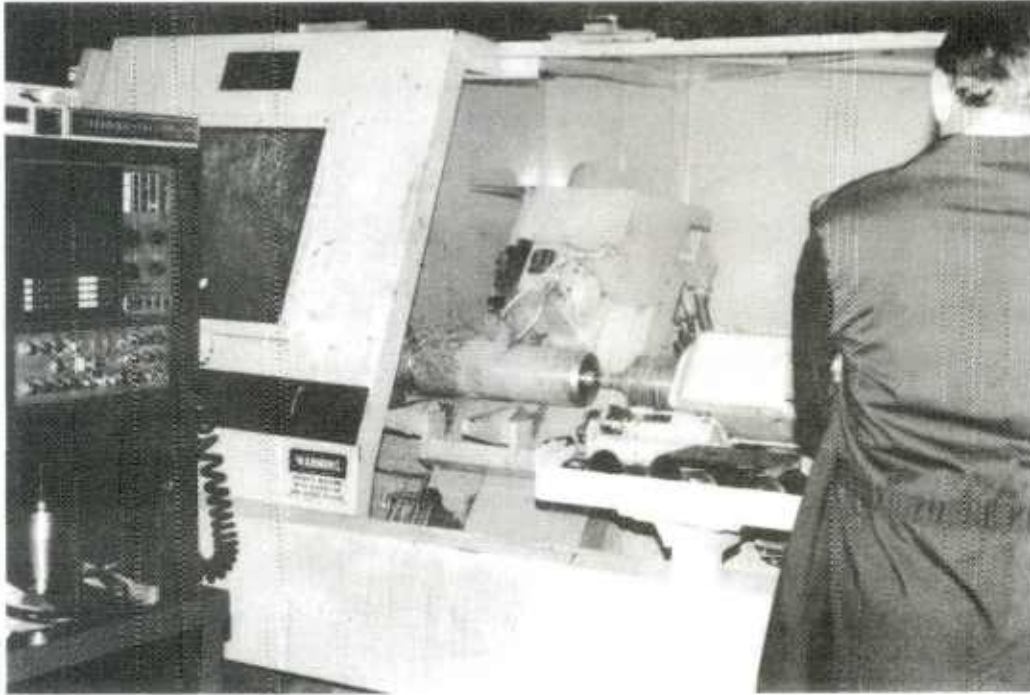
Figure 49. Machining of the M-549 projectile (HF-1 steel) on a J & L numerically controlled lathe.

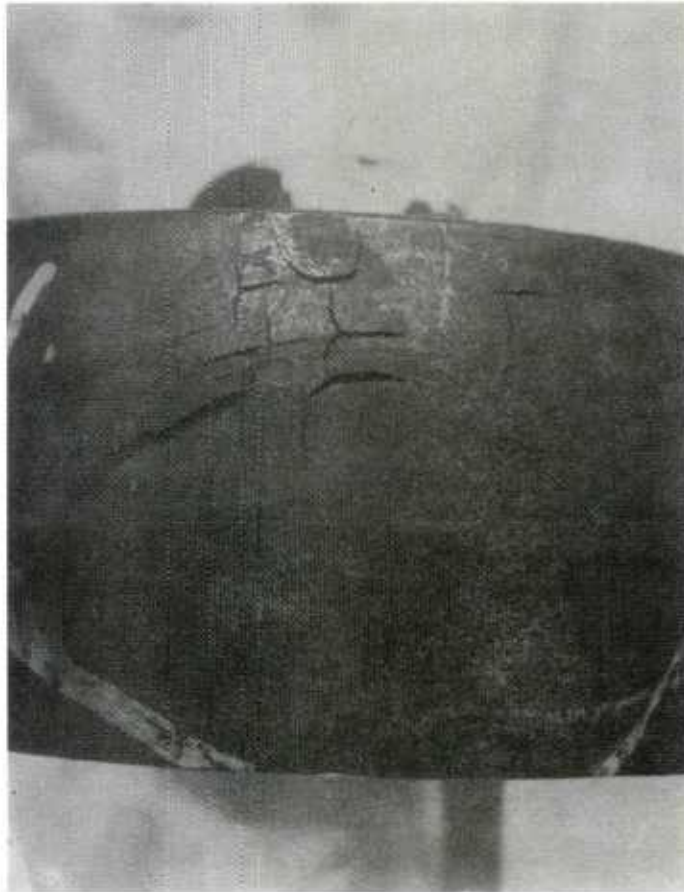
M-549
Forging Defect
Category II

Figure 87. Photograph of O.D. defect. (Shell #1432)
IX Unetched.

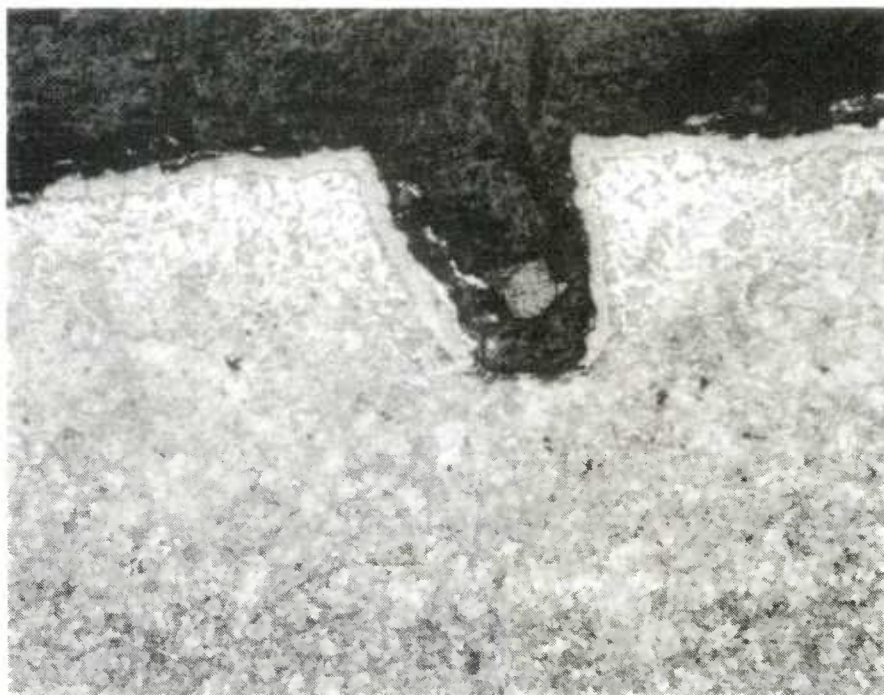
M-549
Forging Defect
Category II

Figure 88. Photomicrograph of longitudinal section showing decarburized area. 63x Nital Etch (Shell #1042)

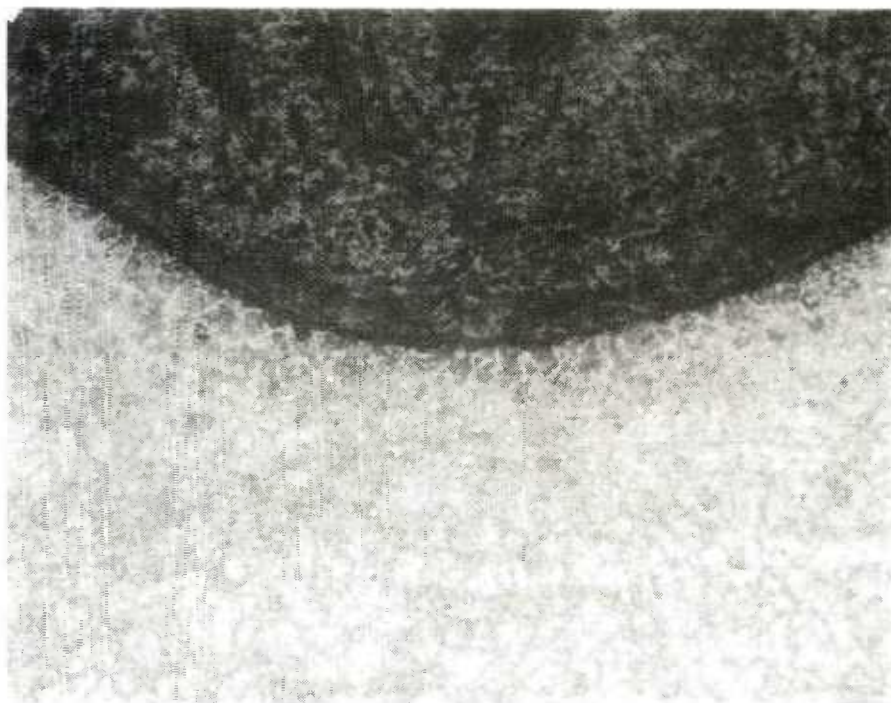
Fig.103. Photomicrograph of longitudinal section of defect
showing no decarburization or flow lines.
63X Nital Etch.

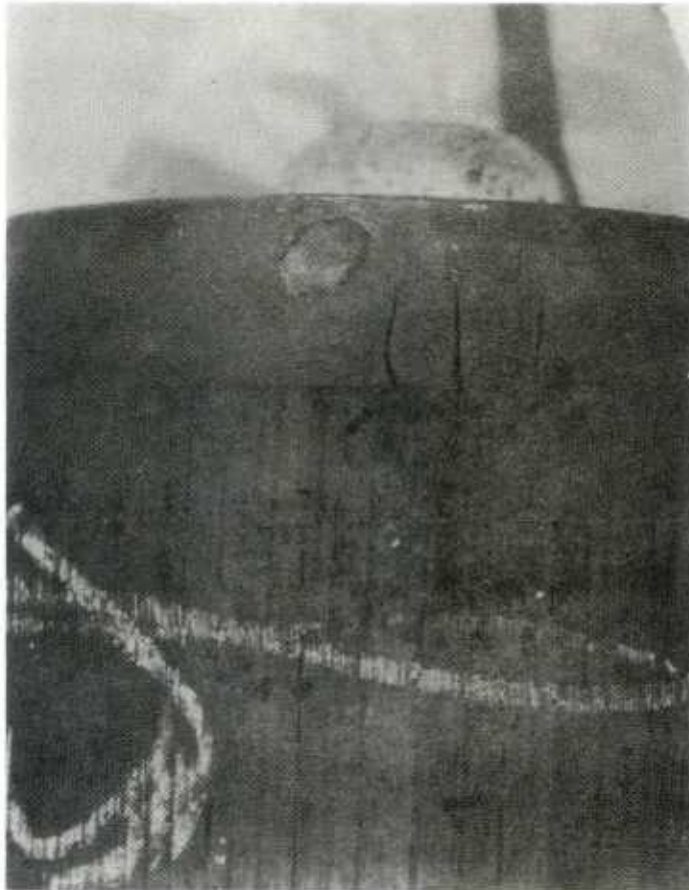
Figure 104. Photograph of longitudinal cracks. (Shell #1011)
1X Unetched.

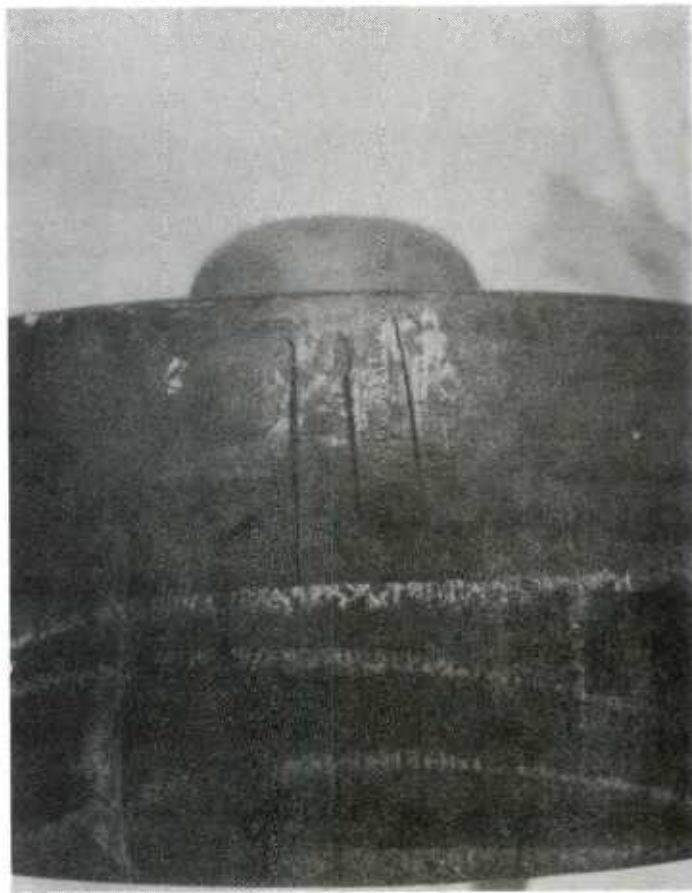
Figure 105. Photograph of longitudinal cracks. (Shell #470)
1X Unetched.

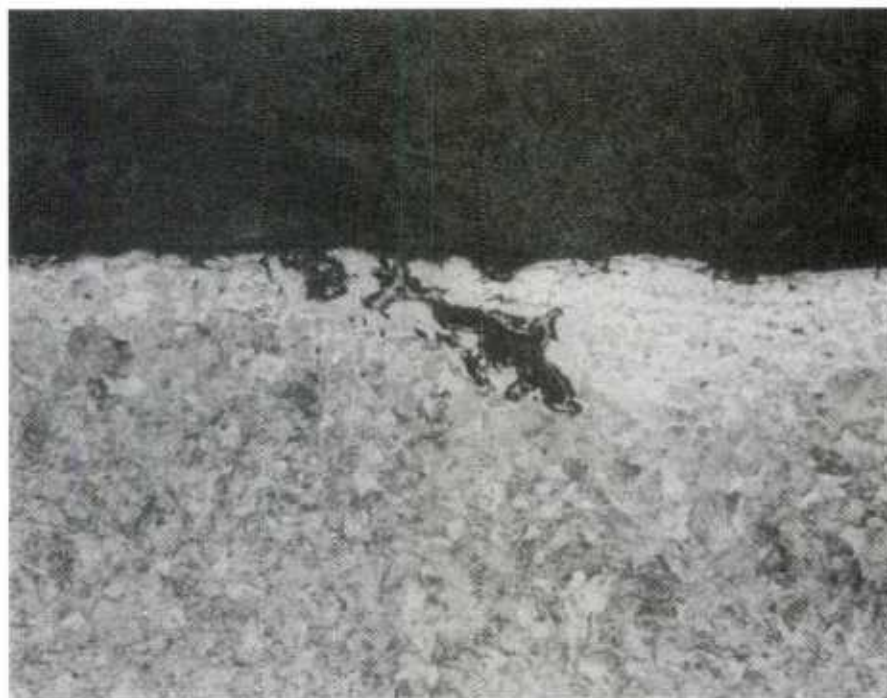
Figure 107. Photomicrograph of cross section of defect. (Shell #1011)
63x Nital Etch

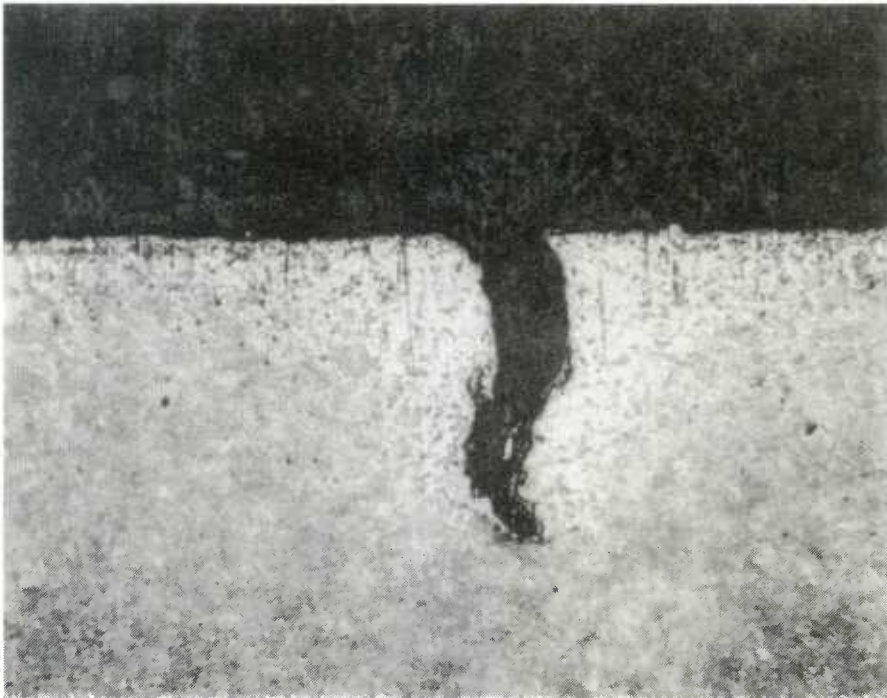
Figure 108. Photomicrograph of cross section of defect. (Shell #470)
63x Nital Etch

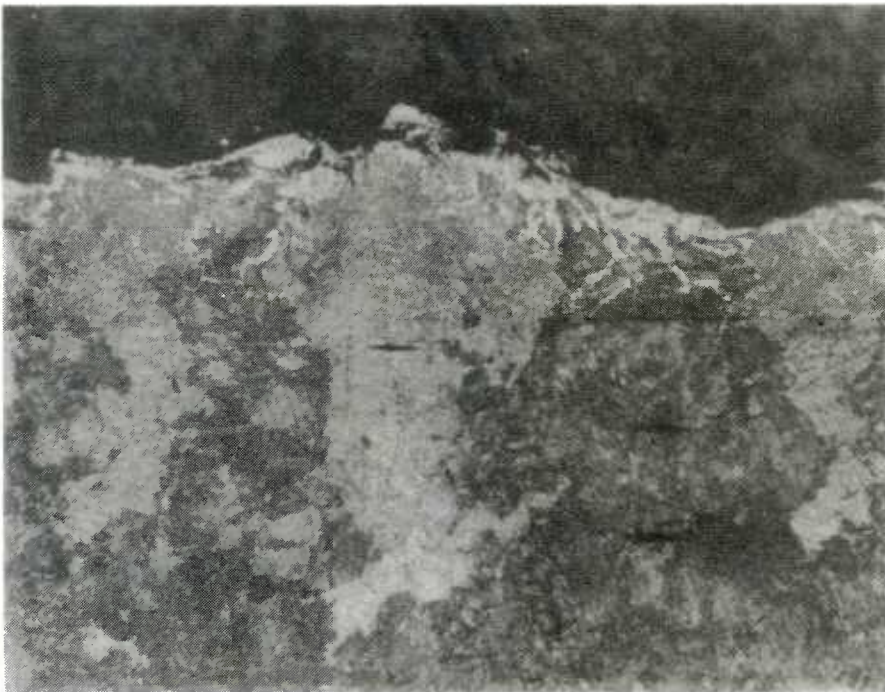
Figure 110. Photomicrograph of longitudinal section showing patches of untempered martensite. 125X Nital Etchant.
